Surface deposits and landslide inventory map of the area affected by the 1997 Umbria-Marche earthquakes

GUENDALINA ANTONINI (*), FRANCESCA ARDIZZONE (**), MAURO CARDINALI (**), MIRCO GALLI (*), FAUSTO GUZZETTI (**), & PAOLA REICHENBACH (**)

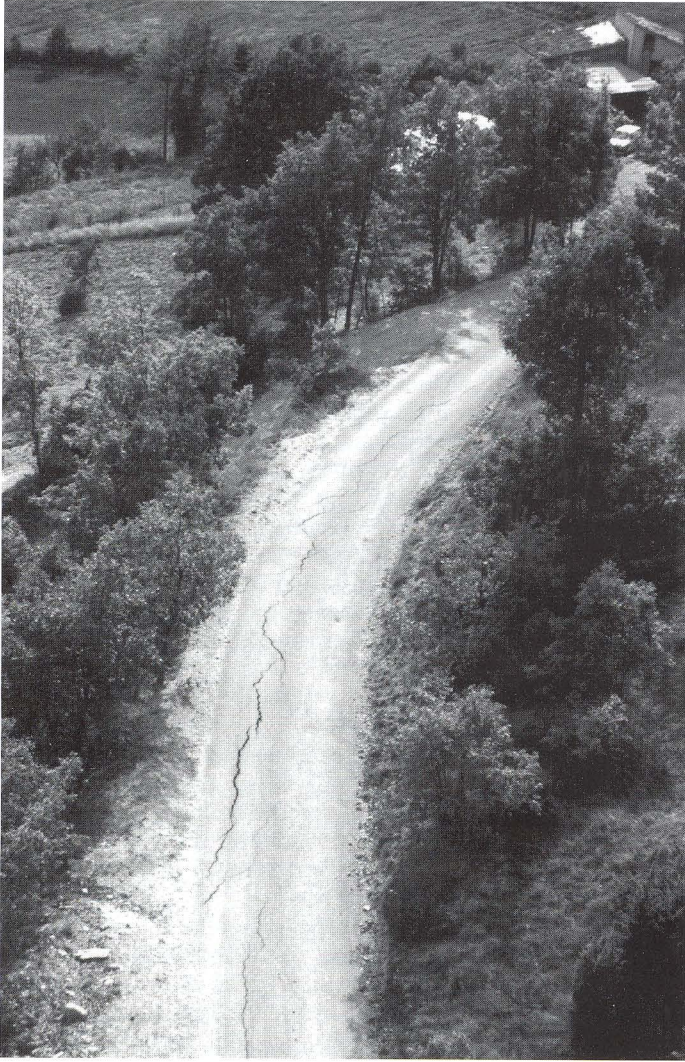
Fig. 4 - Vio. Example of seismically induced ground fractures opened along a road.
- Vio. Esempio di fratture al suolo sismoindotte apertesi lungo una strada.

Ground fractures were observed at 124 sites, for a total of 324 cracks ranging in length from less than 2 meters to more than 300 meters (fig. 3 and fig. 4). The majority of the cracks ranged in length from 10-100 meters, with an average value of about 40 meters. For most of the sites (63%) only one or two cracks were reported. Where more fractures were observed at the same site cracks were parallel, sub-parallel, perpendicular or arranged *en echelon*.

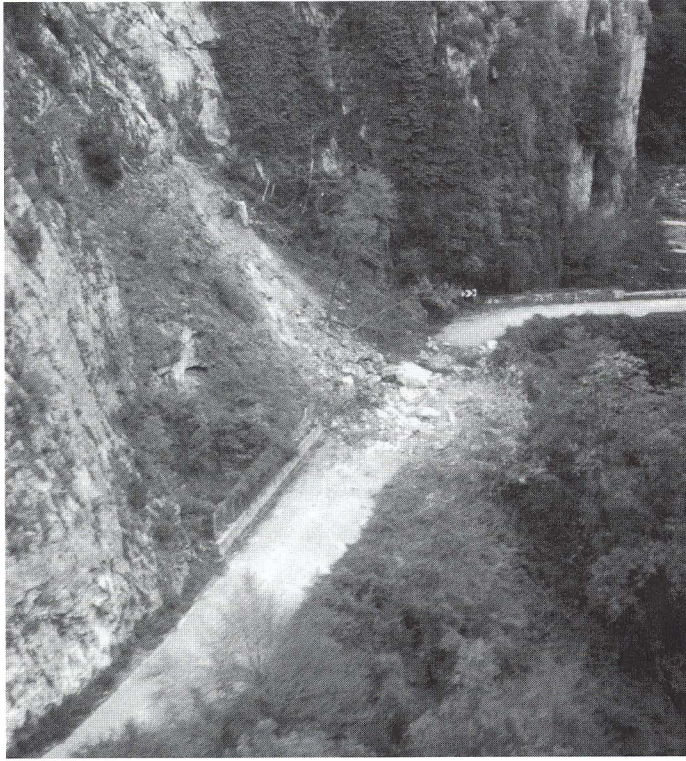
Fig. 6 - Corno Valley, near Triponzo. Examples of an earthquake induced rockslide along a dismissed road. The 14 October 1997 earthquake triggered the landslide.

Landslides triggered by seismic shaking were chiefly rockfalls (fig. 5), minor rockslides (fig. 6) and rock topples (fig. 7). This agrees with what is expected from the

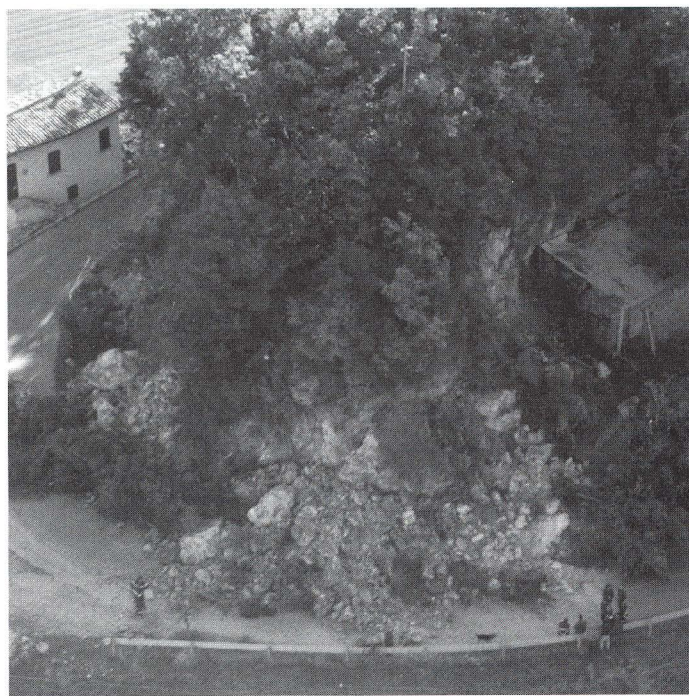
Fig. 7 - Stravignano. Examples of an earthquake-induced rock topple along a road. The travertine cap failed during the night of 16-17 October 1997, and was the result of the cumulative effect of ground shaking produced by several aftershocks.

The earthquakes of 26 September triggered rockfalls, topples and small rockslides ranging in size from a few cubic decimetres to a few tens of cubic metres (for example, at Pale and Bagni di Stravignano – fig. 7). Some of the largest aftershocks also caused such mass movements
